# **REPORT**

### **the Impact of the *Ada Tepe* gold mine, Eastern Rhodope Mountain, Bulgaria, on the hydro morphological status of Krumovitsa River**

#### **Introduction**

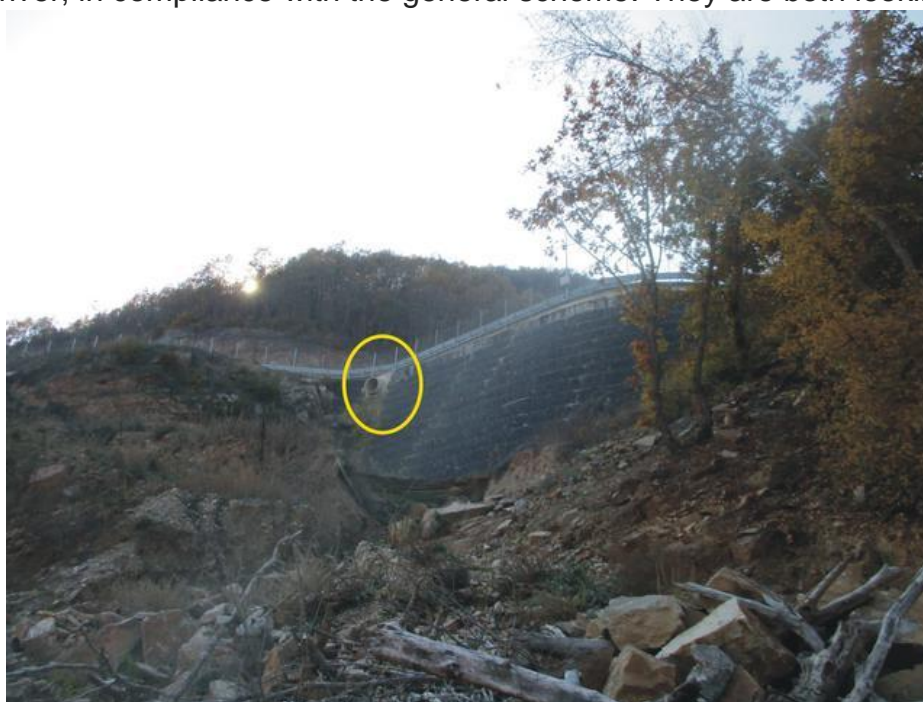
The field study took place on November 13th 2020 /Friday/ and covered 3.0 kilometers long section of the Krumovitsa River, starting 1.0 kilometer above and ending 2.0 kilometers below the south *Ada Tepe* sump, built in a small gully tributary to the Krumovitsa River. All in all the presence of two sumps was registered close to the main river, in compliance with the general scheme. They are both looking alike:

This picture, taken bottom up from the riverside, shows the north sump. Big exhaust pipes /in the ellipse/ are clearly visible at the left hand top corner of each barrage, with one possible purpose: to play the role of spillways. The entire mining area, including the sumps, can be watched in the following video, shot with a drone:

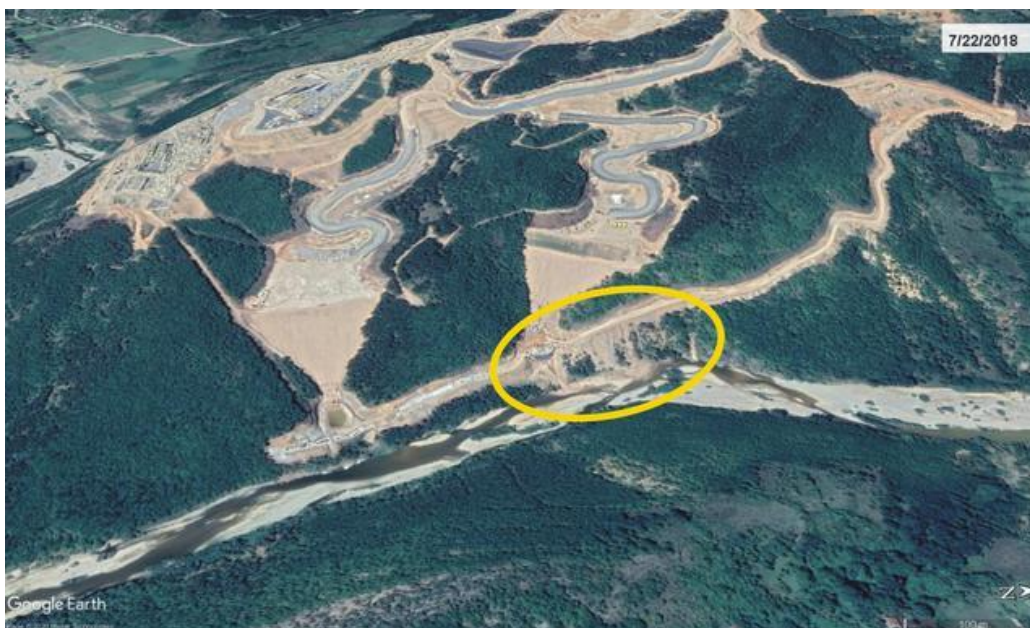
Part of the answer is easy, judging from the satellite pictures downloaded from Google Earth during the construction phase - the date of the following picture is July 22nd 2018, when massive discharge of mud flowing into the river is clearly noticeable under the North sump:

**Based on the findings above, currently it is obvious that the main source of sludge was formed during the construction phase of the project's implementation.**

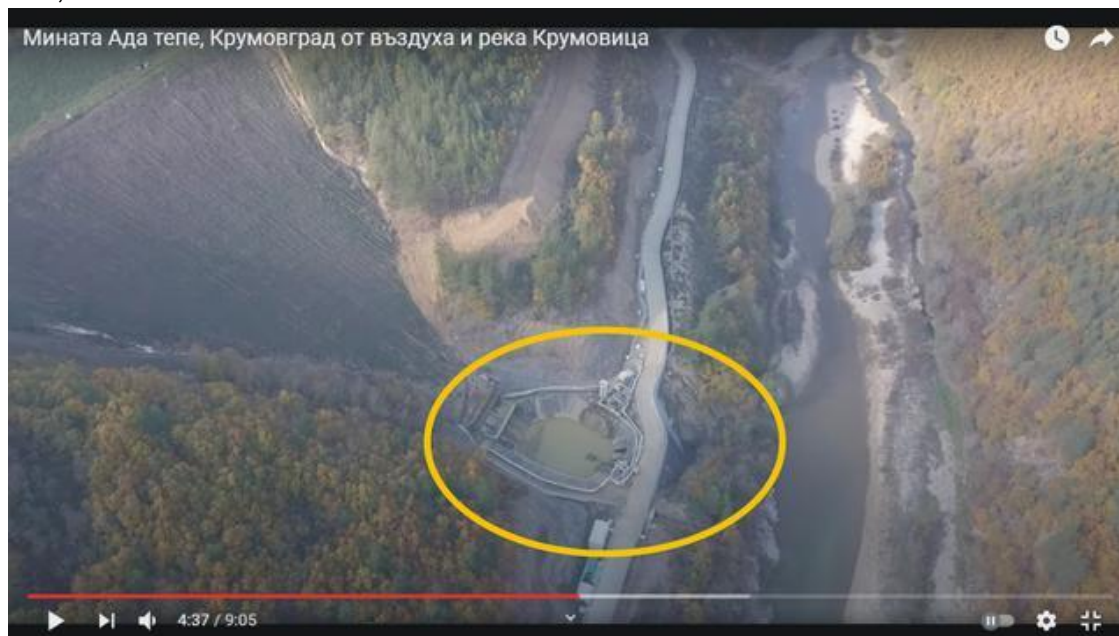
Please note that the south sump holds a really small amount of water during our field visit, carried out on November 13th 2020:

This picture is displaying the undisputed facts that:

1. There is enough volume to collect additional rain waters instead of discharging them directly into the riverbed.
2. There is no partition wall in the sump, while the presence of such partition is claimed in the letter of RIEW *Haskovo*.

According to the letter of RIEW *Haskovo*, some part of the "non contact" rainwater is collected in the sumps, while another part is dumped into the river even when the sumps are empty, because in the same letter on page 1 RIEW states that the south sump was only 21% full at the time of their inspection...

Dumping surface rain waters /whether "contact" or not/ with unknown chemical contents from the industrial mining area directly into the river should not be allowed. Otherwise, these waters should also be tested. Dundee Precious Metals has not published water monitoring reports since 2017 and it is unclear if such monitoring is carried out by the company, by the EBRD or by their consultants.

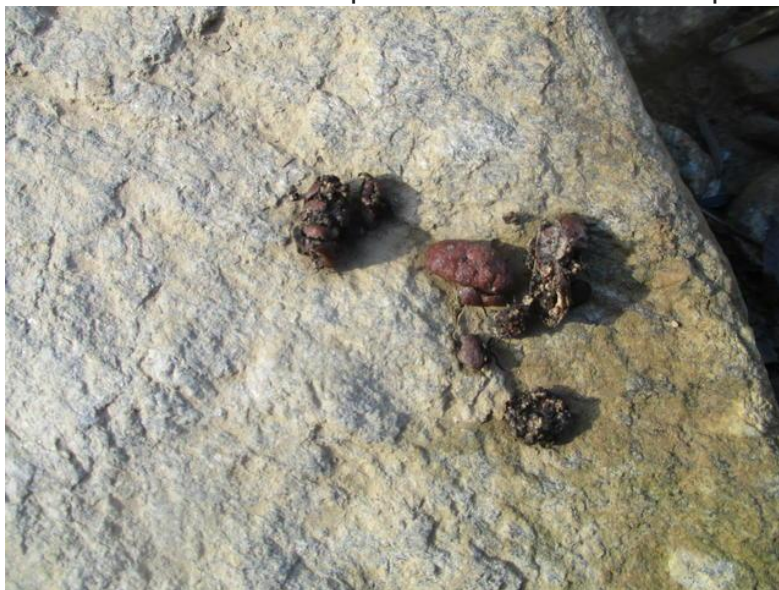
Another positive sign was the presence of fresh traces of otter excrements alongside the river, registered some 350 meters upstream of the south sump. Here they are:

These traces come to prove that there still is sufficient nutritional base for the otter, which was not chased away from the surrounding area after more than one year of operation of the mine.
