REPORT

the Impact of the *Ada Tepe* gold mine, Eastern Rhodope Mountain, Bulgaria, on the hydro morphological status of Krumovitsa River

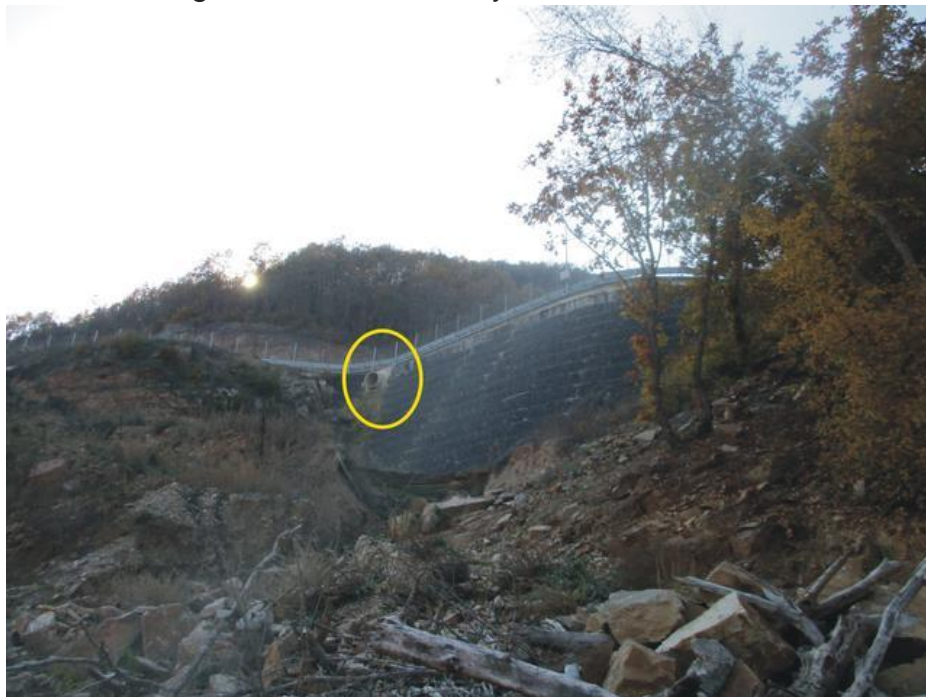
This picture, taken from the riverbank, shows the north sump. Big exhaust pipes (indicated in the yellow ellipse) are clearly visible at the left hand top corner of each barrage, with one possible purpose: to serve as spillways. The entire mining area, including the sumps, can be viewed in this video, shot with a drone:

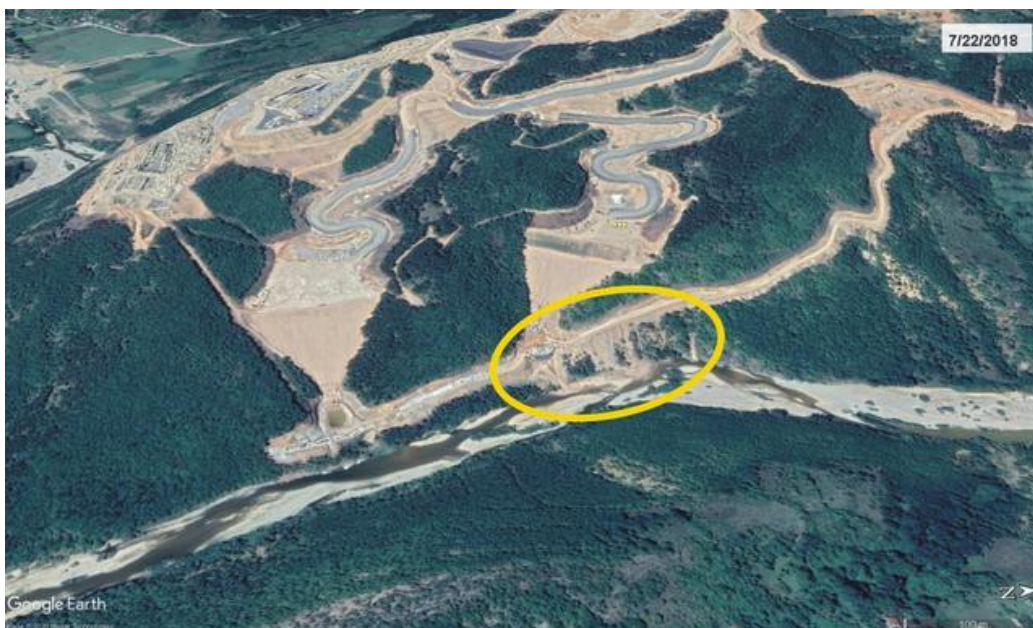
Part of the answer is easy, judging from the satellite pictures downloaded from Google Earth during the construction phase - the following picture was taken on 22 July 2018, when a massive discharge of mud flowing into the river is clearly noticeable under the north sump:

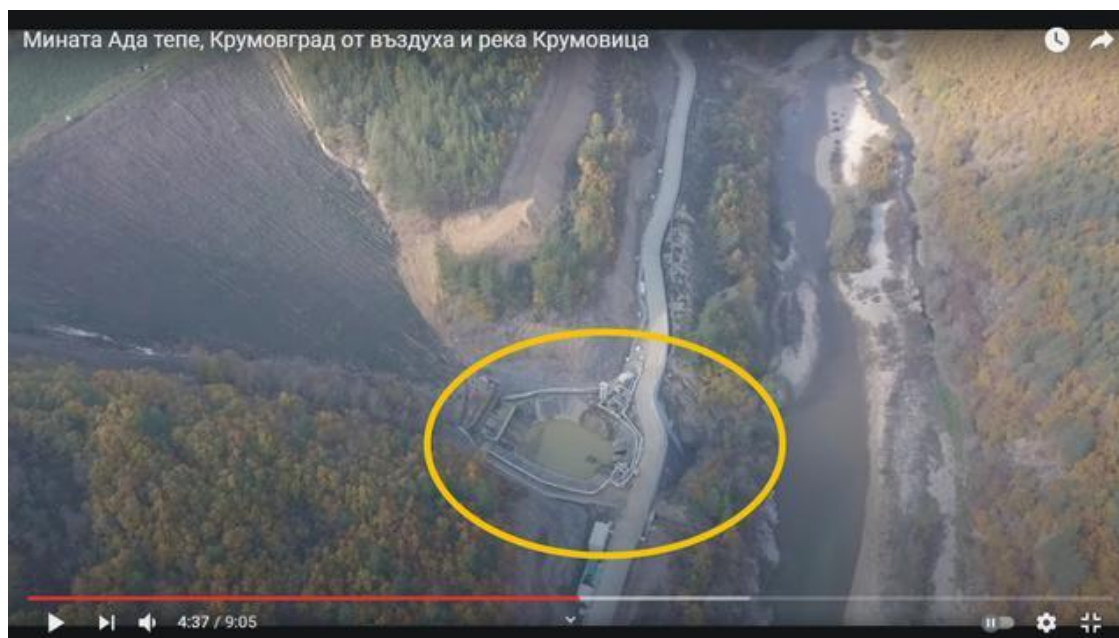
The south sump held a small amount of water during the November 2020 field visit:

This picture displays the undisputable facts that:

1. There is enough volume to collect additional rain water instead of discharging it directly into the riverbed.
2. There is no partition wall in the sump, claimed in RIEW Haskovo's the letter.

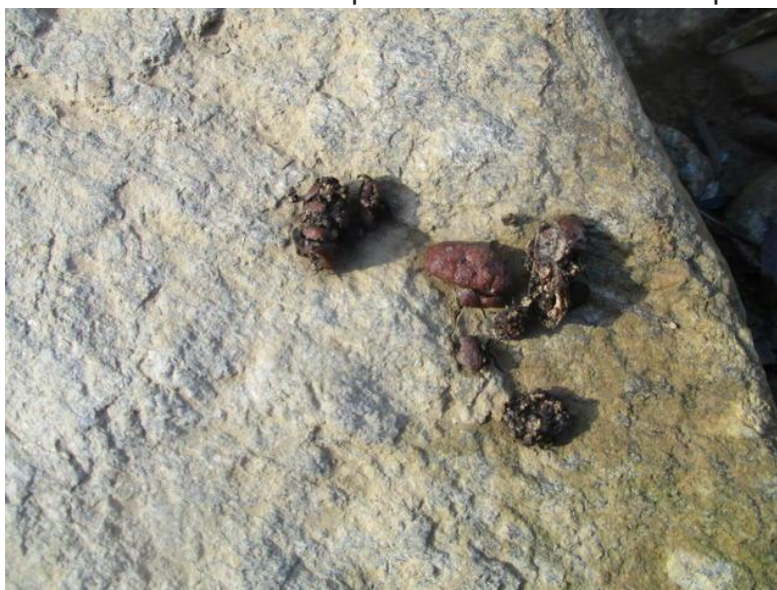
Another positive sign was the presence of fresh traces of otter excrements alongside the river, registered some 350 metres upstream of the south sump:

These traces demonstrate that there is still a sufficient nutritional base for the otter, which has not been chased away from the surrounding area after more than one year of the mine's operation.

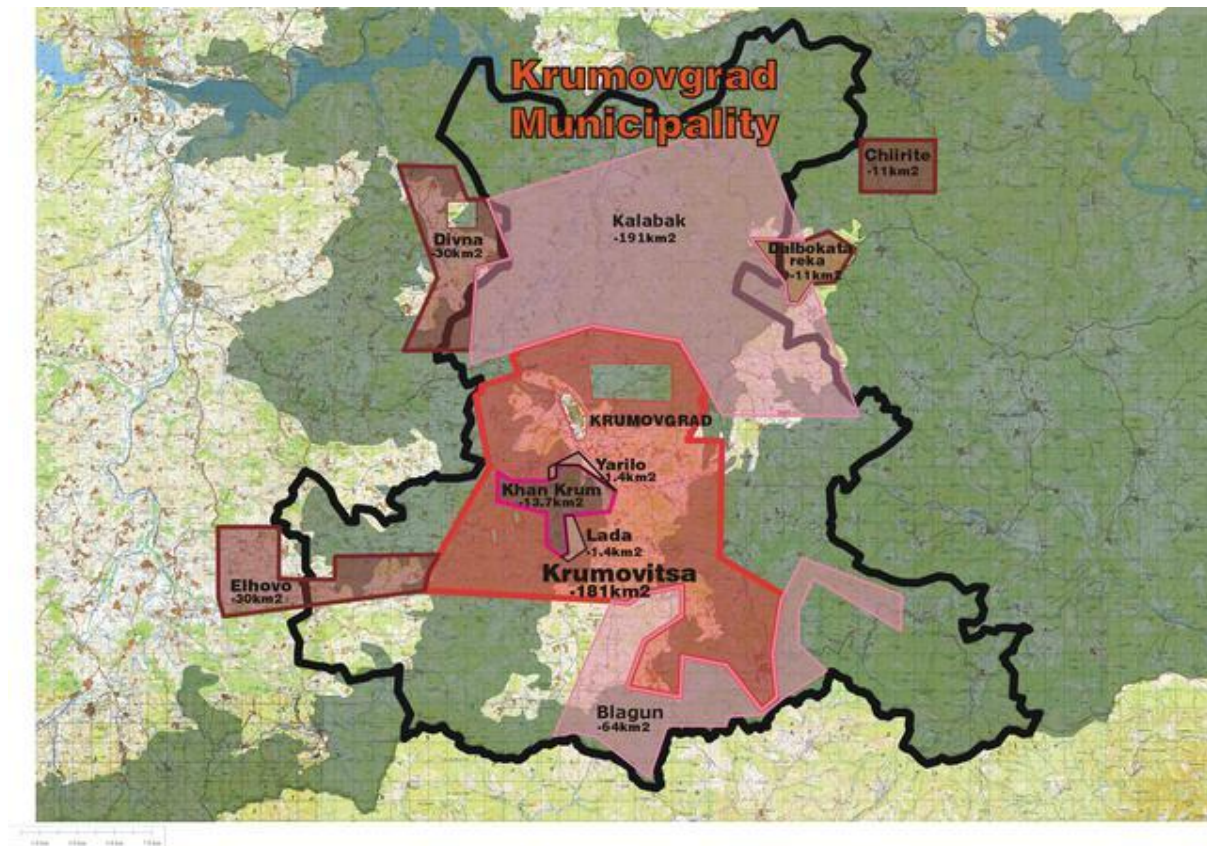
Moreover, during the preparation of this report, another tender invitation appeared on the Ministry of Energy website, concerning metal search and exploration in another new large mining field called Krumovitsa /**181**km²/, which falls entirely within the boundaries of Krumovgrad municipality. The tender procedure is initiated by an unknown investor, meaning it may not be Dundee Precious Metals. However, the borders of this particular field fully cover the borders of the existing field known as Iran Tepe, which is owned by Balkan Mineral Mining, therefore Dundee Precious Metals may still be involved. The boundaries of all future mining plans are displayed on the following map and the Krumovgrad municipality borders are drawn with thick black line:

The exploration fields Kalabak and Blagun, which do not belong to Dundee Precious Metals or its subsidiary Balkan Mineral Mining, are colored in light pink.

This map shows only the mining exploration fields in the municipality of Krumovgrad, but there are many other permits for exploration within the same Habitats Directive site, which is indicated in dark green on the map..
